# **UK Technical Bulletin**

# Pilkington Activ™ Blue coated side detection

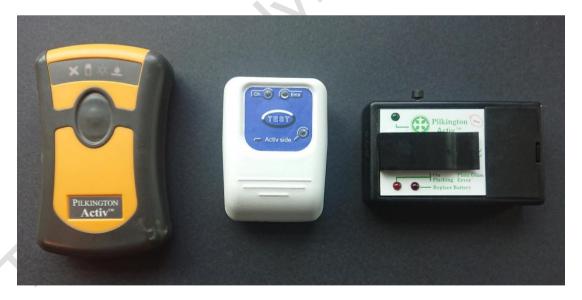
Figure 1: Examples of Pilkington Activ™ detectors

These instruments – examples of which are shown in Figure 1 - operate based on the difference between reflectivity of the Pilkington  $\mathbf{Activ}^{\mathsf{TM}}$  coating and uncoated glass. As the Pilkington  $\mathbf{Activ}^{\mathsf{TM}}$  Blue coating has a higher reflectance than uncoated float glass, these instruments can be used in the usual way to identify the coated surface.

In the case of Pilkington **Activ SunShade™** Blue, as this is a dual-coated product, these types of detectors will indicate that a coating is present on both surfaces. It is possible to distinguish between the Pilkington **Activ™** Blue and Pilkington **SunShade™** coatings visually as the Pilkington **SunShade™** coating has a distinctly greyish appearance relative to the Pilkington **Activ™** Blue coating.

Alternatively, as the Pilkington **Activ**<sup>™</sup> Blue coating is slightly conductive, a digital multi-meter or fuse tester can be utilised to check for electrical continuity. Only the Pilkington **Activ**<sup>™</sup> Blue coating will give a positive reading for continuity. This method can also be employed in-situ once the glass has been installed to check if an IGU has the Pilkington **Activ**<sup>™</sup> Blue coating on surface one.

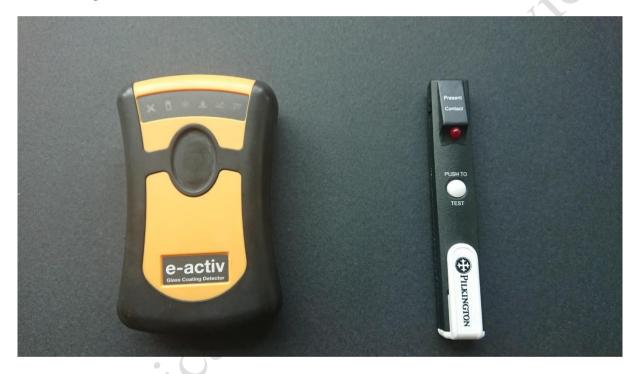
Figure 2: Examples of low-e coating detectors

Once it has been established that the product is Pilkington **Activ**<sup>™</sup> Blue, these instruments – examples of which are shown in Figure 2 - can also be used to identify on which surface the coating is present. Some models of low-e detectors can differentiate if the coating is present on the side that is in contact with the detector or if it is present on the opposing side of the glass. This test can also be used in-situ to check if an IGU has been assembled and / or installed correctly. If any doubt remains regarding positioning of the Pilkington **Activ** Blue coating, this can be verified using the digital multi-meter or fuse-tester method described previously. (The Pilkington **Activ** coating should be situated on surface 1 of the IGU, counting from outside.) Note that, for Pilkington **Activ** SunShade Blue, only the Pilkington **Activ** Blue coating will read as a low-e coating.

As the Pilkington **Activ**<sup>TM</sup> Blue coating is slightly conductive, it will also be detected by low-e coating detectors or will read as low-e for dual purpose (low-e and self-clean) detectors. To avoid confusion, visual inspection will give a clear indication if the glass tested is a low-e glass as such products typically have a high light transmittance, whereas Pilkington **Activ**<sup>TM</sup> Blue is noticeably blue in appearance and has a much lower light transmittance.
